# REPERTORY THEATRE

## REPERTORY THEATRE ASSESSMENT

4 Ridgway Street, Whanganui

Date: 29 November 2021  
Job: E9718

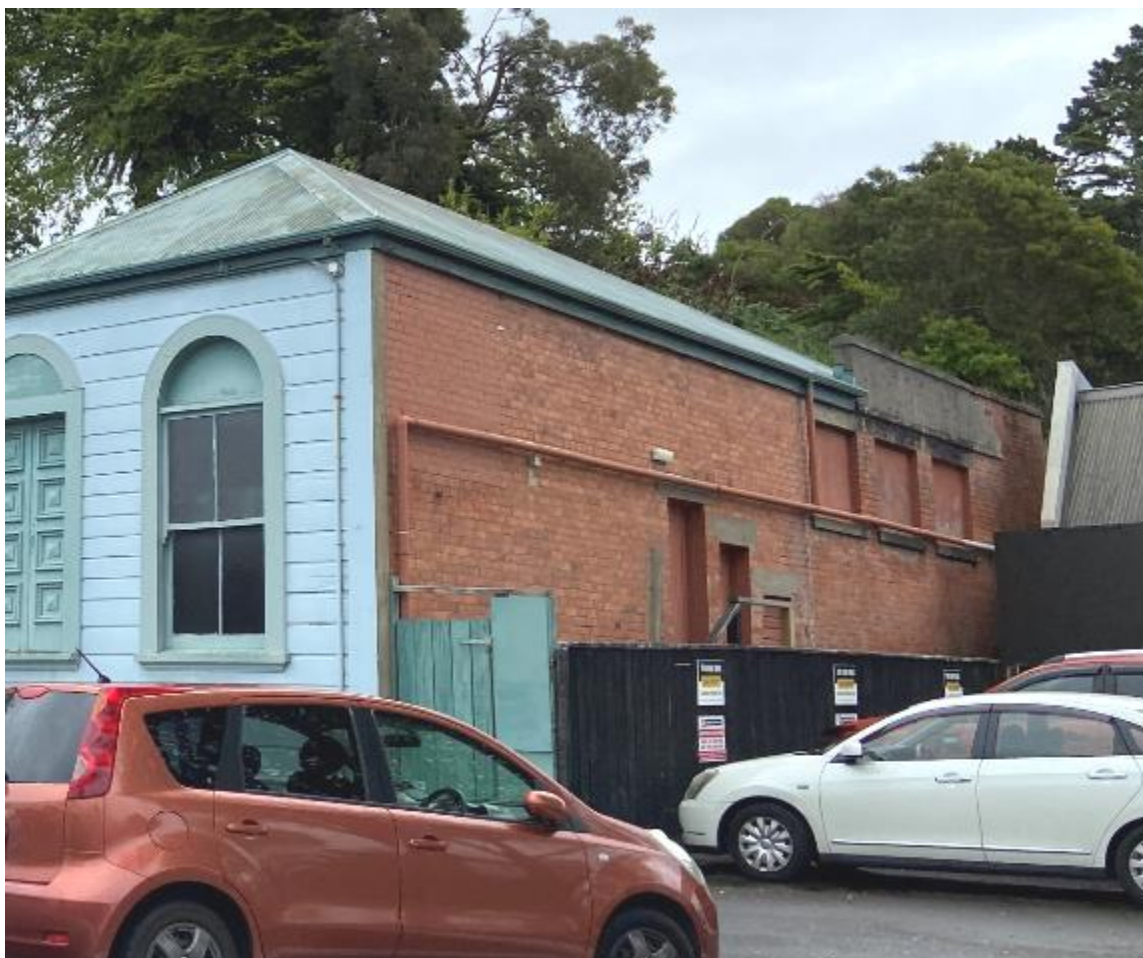
Fortunately, the unreinforced brickwork on this building is limited to the two end walls. However, these walls do represent a risk to the building and its occupants as they **are not adequately** restrained by the remainder of the building.

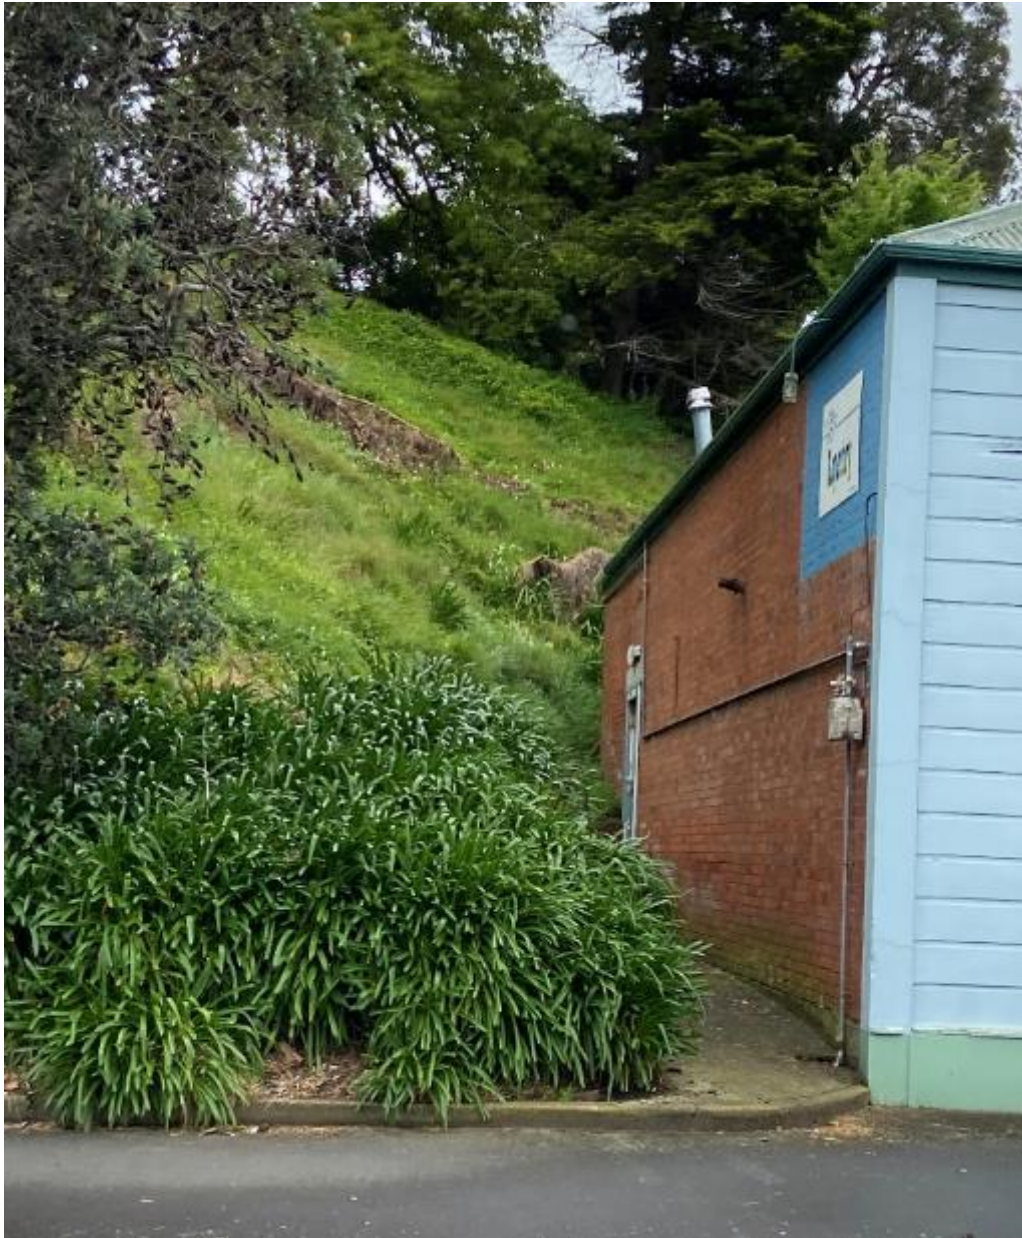
At the rear of the theatre a steep sand bank extends up to the road around Queens Park. It is difficult to accurately determine the slope of this bank due to the vegetation, however we have approximately measured it using an Abney level. The maximum slope is around 33 degrees at the bottom of the embankment with the slope progressively reducing the higher you go.

We understand that Whanganui District Council (WDC) is currently investigating remediation of this slope including brick excavation to reduce the embankment slope and appropriate planting.

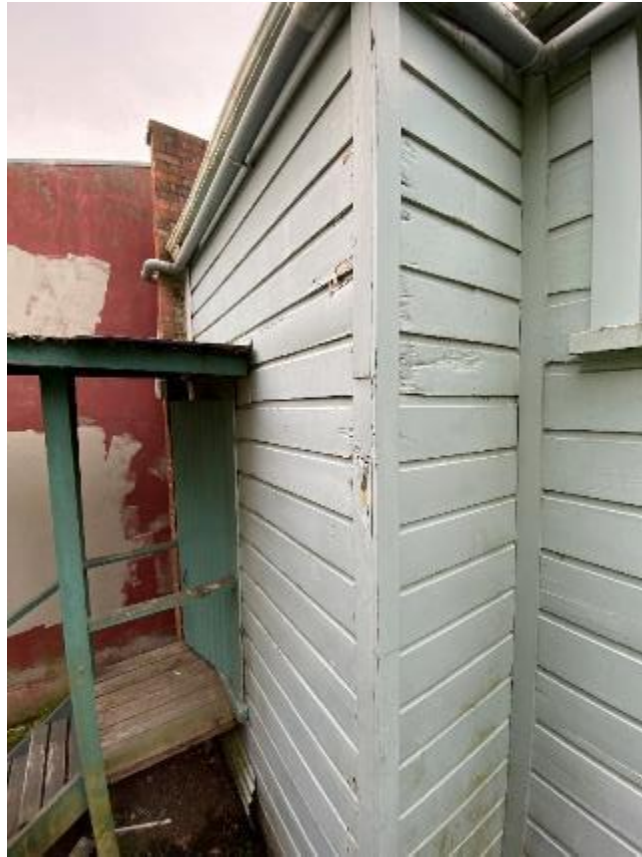
1. Rotten weatherboards – particularly at the rear of the building.

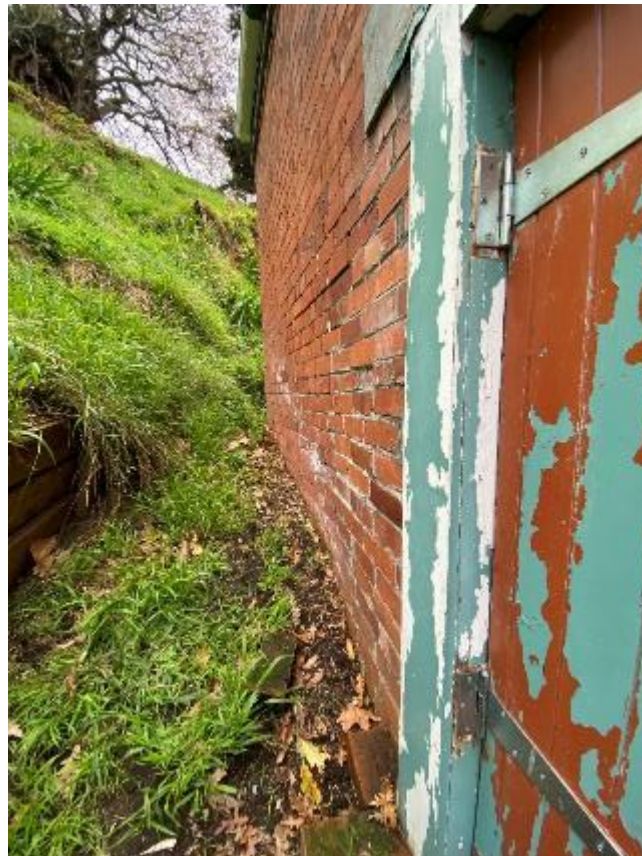
2. Weathered mortar to the unreinforced masonry walls. There are mortar beds that can be easily scraped out with a soft stick.

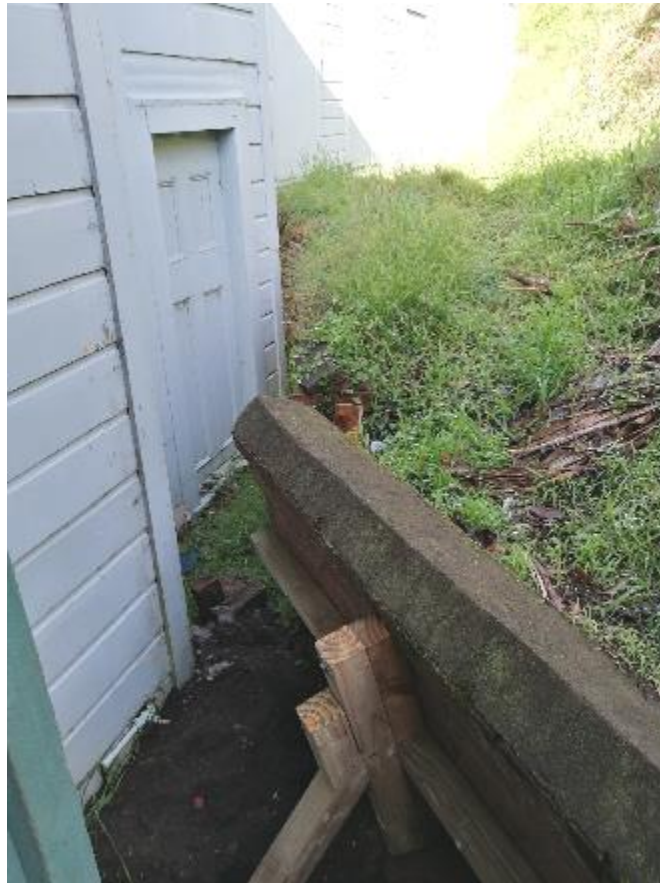
3. At the rear of the property, an unreinforced masonry retaining wall has failed. It is leaning at an incline of approximately 20 degrees off vertical and propped to the external steps. Whilst we do not consider this poses an immediate risk to the building or its occupants, it will eventually need to be replaced. We understand that the bank remediation work will include a replacement retaining wall at the rear of the theatre, approximately 1.5m off the building.

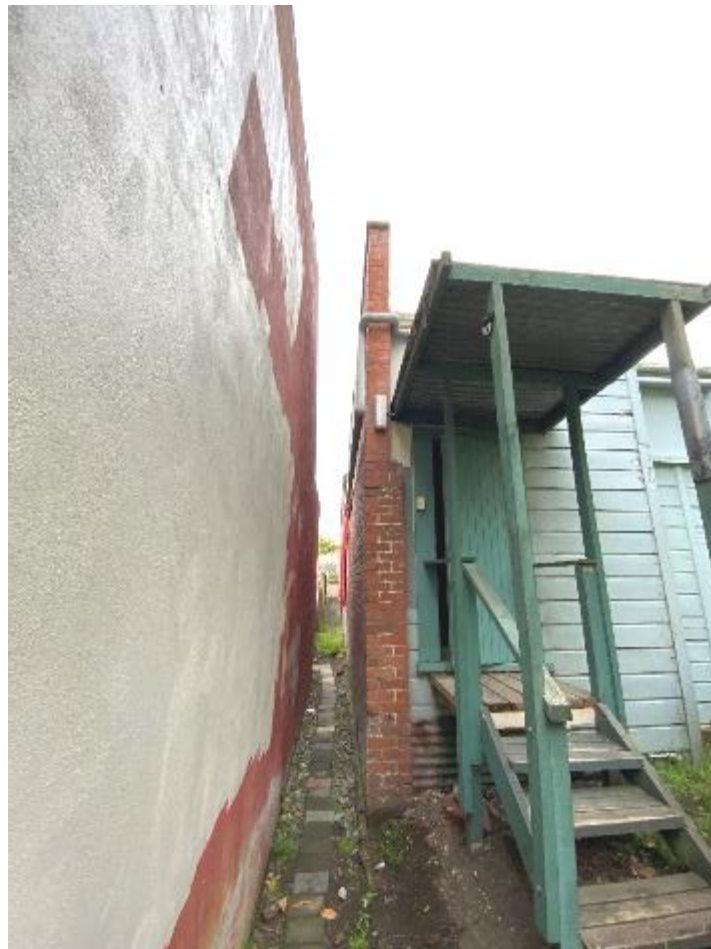
The greatest seismic risk associated with the building comes from the two unreinforced masonry (URM) walls at each end of the theatre. We have assessed their connections to the building ceiling and floor, then their ability to span vertically between the ceiling and floor assuming the connections are or could be made adequate.

Feature	Ratings
URM Walls (Vertical Span)	30% NBS
URM Parapets (Cantilever)	25% NBS
Fixings	<10% NBS

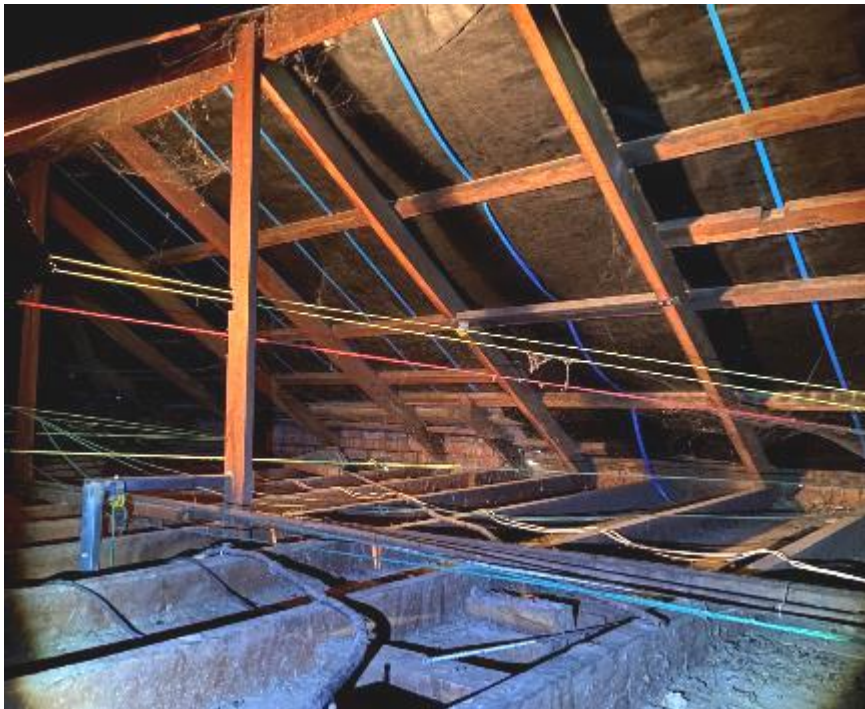
The roof framing appears consistent with construction techniques at the time of construction. Inspection of the roof framing above the stage / backstage area was made. Thus, it does not meet current code provisions.

It is likely that some remedial work will be requested once refurbishment commences. This may be as simple as improving fixings between elements but would also require some additional elements/strengthening.

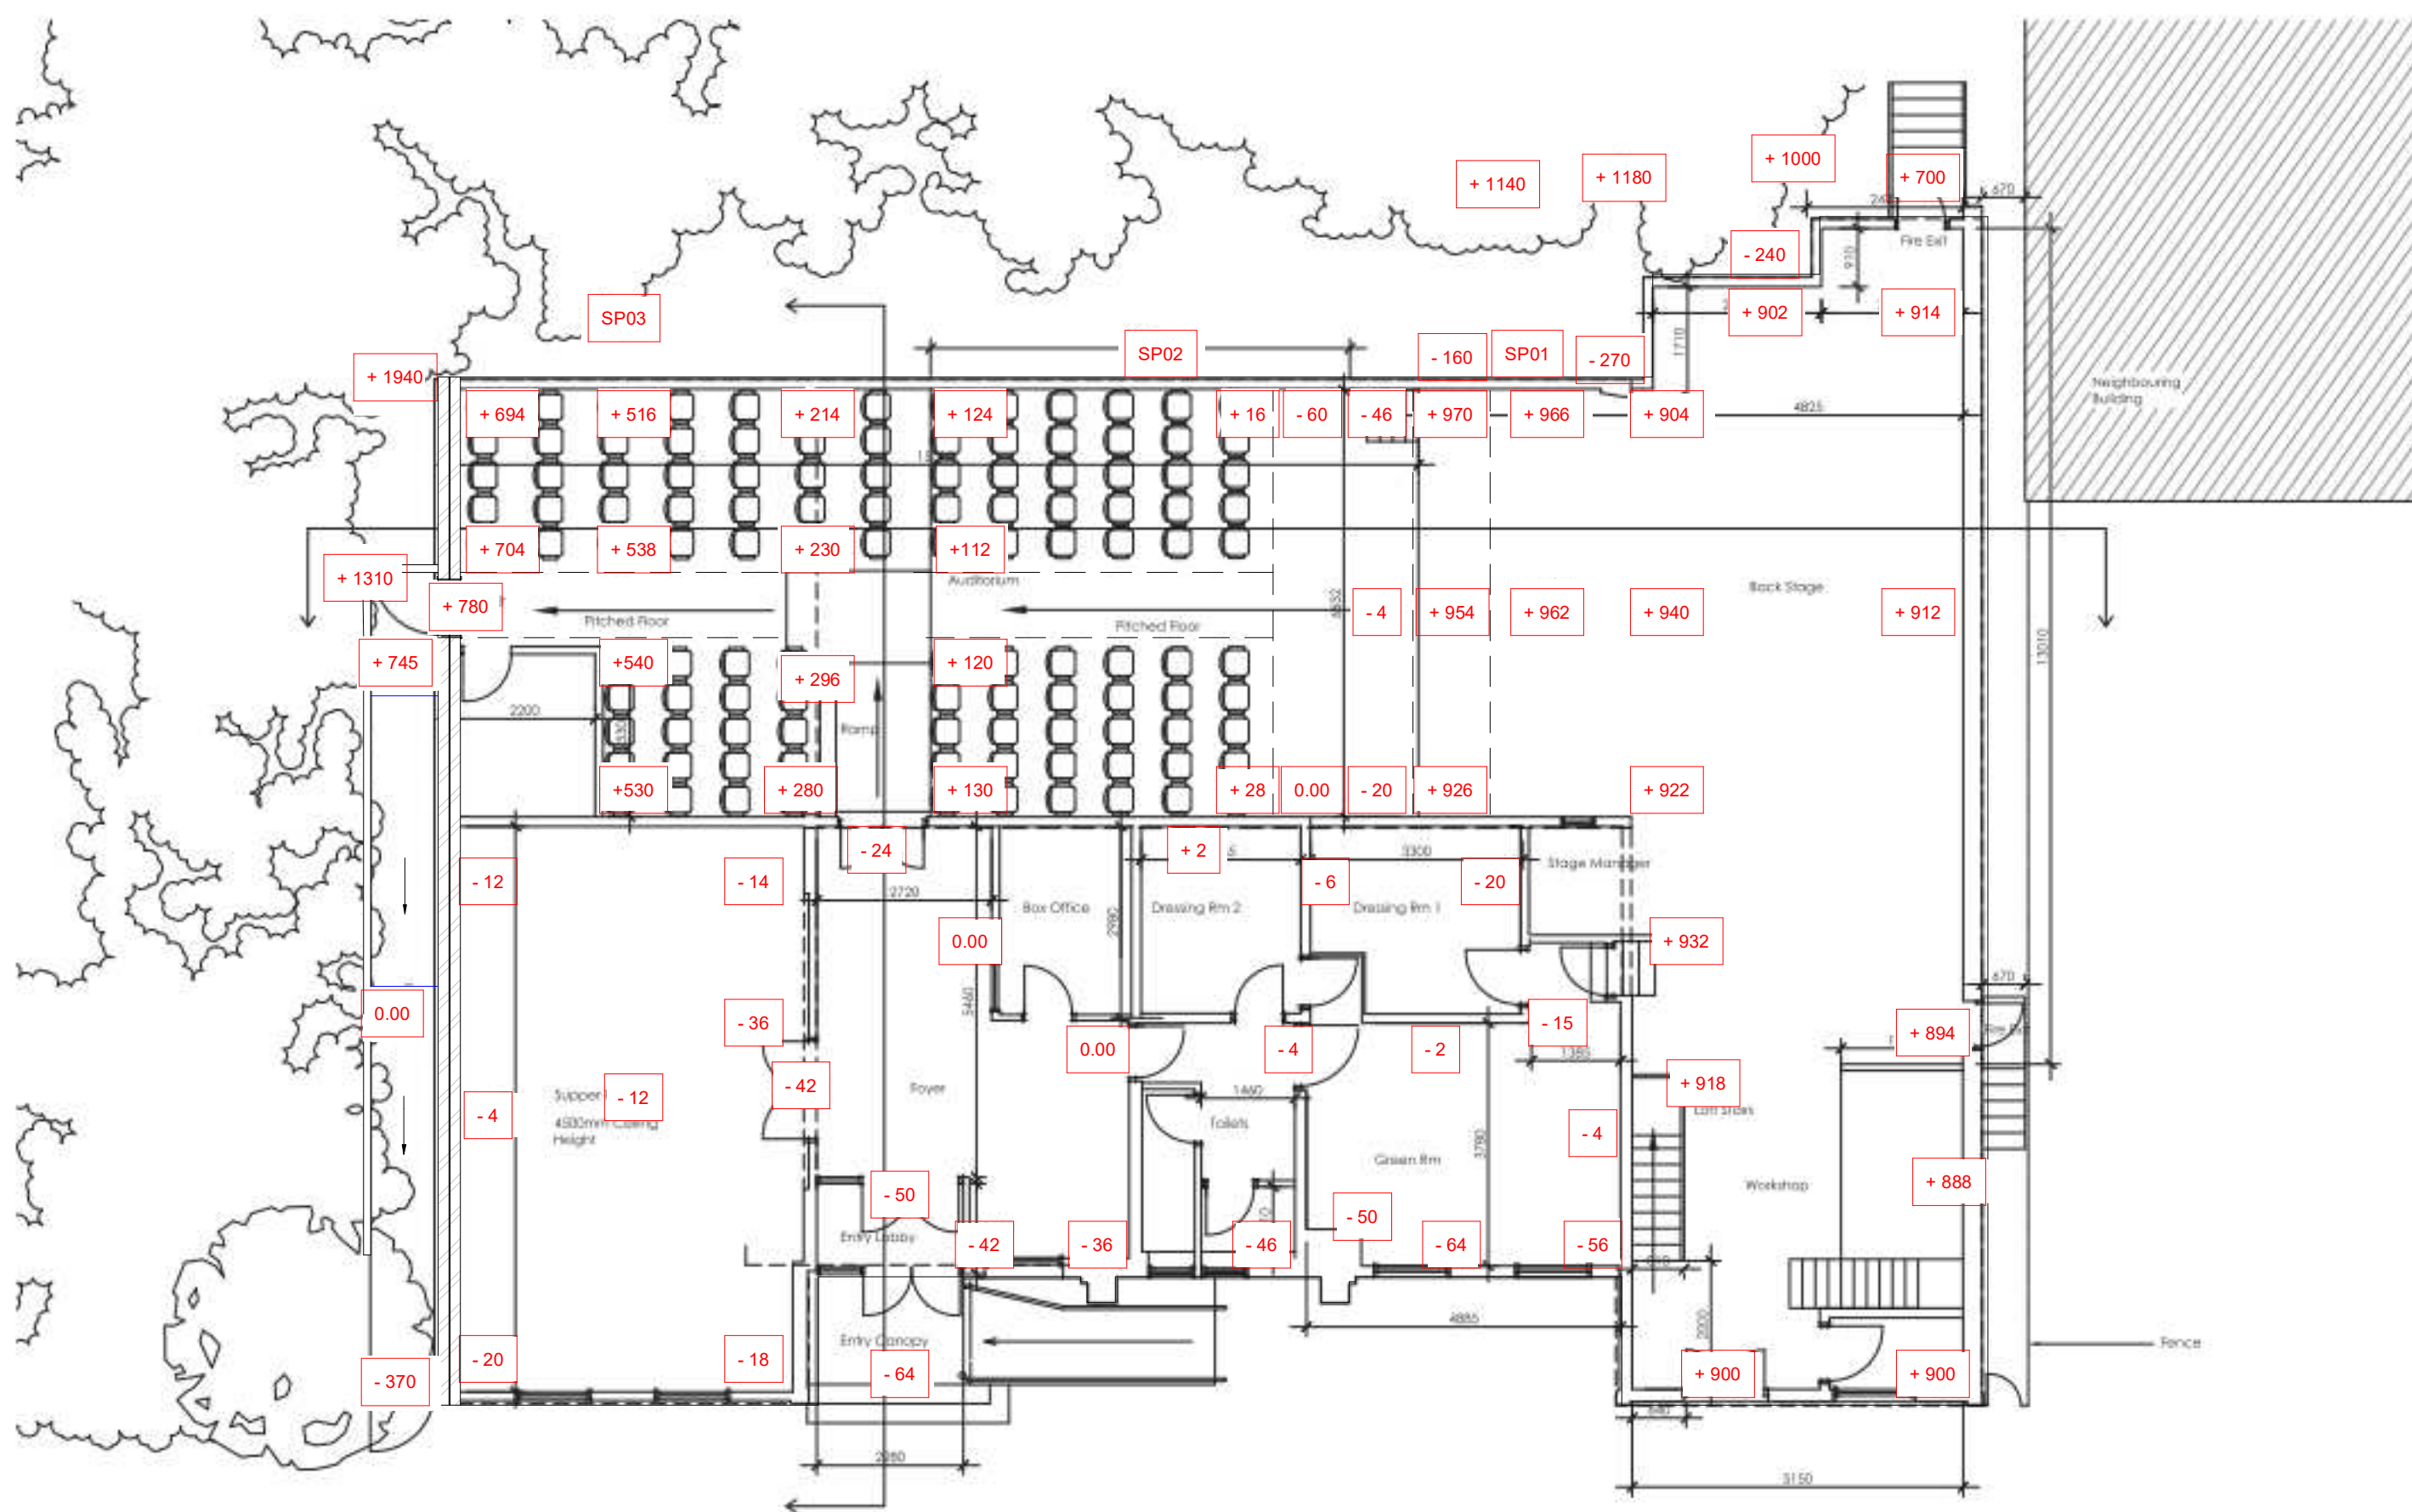
LEVELS PLAN  
1 : 100

The differential settlement within this area is as much as 64mm between the box office and the external wall of the Green room.

2. Stage. The stage which sits nominally 1 metre above the common floor. However even within this platform, differential settlement of up to 70mm was recorded.
3. Auditorium. The auditorium comprises of a sloping floor from the stage to the control booth. Hence, it is difficult to measure differential settlement in that direction. However, there is significant settlement along a single row of seating which, presumably, would have been constructed at a uniform height above the original floor.
