# CONSERVATION REPORT

## The WHANGANUI REPERTORY THEATRE

ADDRESS: 4 Ridgway Street, Whanganui Old Town  
DATE PREPARED: 3 December 2021  
REVISED: /  
PREPARED FOR: The Committee, Whanganui Repertory Theatre  
Incorporated  
PREPARED BY: Drawingroom Architecture & Interiors in association with  
BPL Group & Fire Engineering Services Ltd.  
LEGAL DESCRIPTION: Pt Section 548, Town of Wanganui

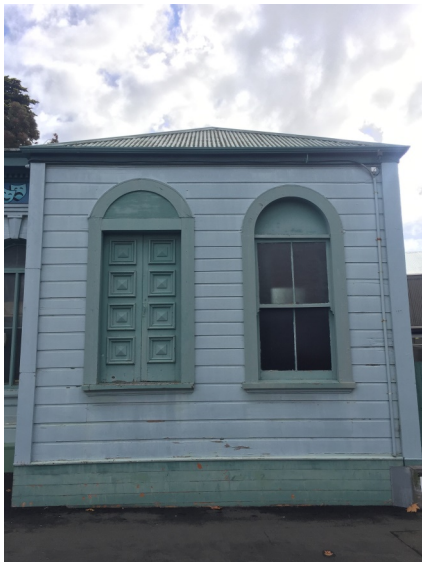
Front Façade on North Eastern extension:

**Window:** Timber Double Hung Sash Window, Timber Sill, Jambes & facing with single pane of frosted glass and paint finished arch top panel. Requiring fresh paint but otherwise in good condition. **b**

**Door:** replaced window in order to provide prop access point for offsite fabricated props for the theatre in the early 20<sup>th</sup> C. Requiring fresh paint but otherwise in good condition. **b**

**Weather boards & Corner boards:** 255mm cover paint finished weatherboards. Evidence of isolated rot which will require further inspection and in instances to be replaced **b**

**Gutter:** Periodically replaced and of little architectural merit **d**

**Foundation wall:** In good condition. Paint finished. **c**

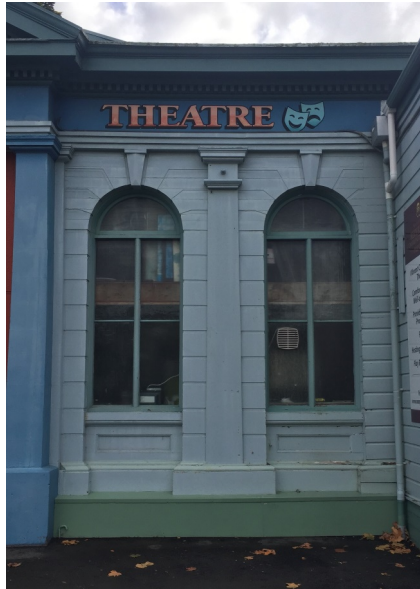
**Front Façade on North Eastern side of original façade:** **B**

**Windows/Moldings/Facings:** Original fixed timber Windows, Timber Sills, Jambs & facings with glazed arch top window. Single pane frosted glazing. The view into these windows is currently obstructed by the 1956 addition of the mezzanine floor in the middle of the glazing which detracts from the external quality of these windows. Joinery requires fresh paint but otherwise in good condition. **a**

**Air Vent in window:** On the lower left pane of the right window an air vent detracts from the existing façade and should be removed and replaced by a better concealed ventilation alternative. **x**

**Rusticated Weatherboards & Pilaster:** Original details which should be maintained and restored to ensure their longevity. Original photos indicate planted timber panels were positioned along the column to imitate masonry construction, evidence of which can still be seen on close inspection. The mock stonework appearance worked into, and onto, the horizontal tongue & groove timber cladding, is significant. **a**

**Weatherboards on Eastern Side:** Weatherboards matching those of the 1904 extension have replaced the original boards behind the downpipe. These are in relatively good condition but detract from the aesthetic of the original façade. **c**

**Entablature and Ashlar details:** Original details which should be maintained and if necessary restored to ensure its longevity. Currently requiring fresh paint but otherwise in good condition. **a**

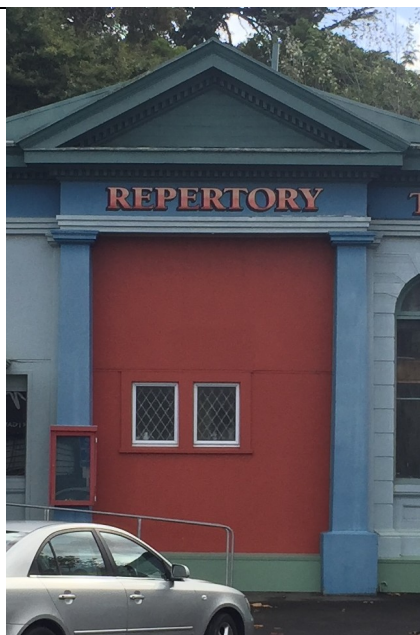
**Central Front Façade:** **C**

**Plaster cladding:** The 1957 alterations led to the replacement of the original entrance and portico with a plain paint finished stucco wall. These alterations were financed by a small interest free loan which was unfortunately stretched too thin to adopt a more sensitive approach and resulted in much of the architectural merit of the main façade to be lost. As a result of this an effort should be made to replicate the original features and reinstate a central entrance to mirror the original Library façade. **x**

**Entablature:** Original details which should be maintained and if necessary restored to ensure its longevity. Currently requiring fresh paint but otherwise in good condition. **a**

**Pediment:** Original details which should be maintained and if necessary restored to ensure its longevity. Currently requiring fresh paint but otherwise in good condition. **a**

**Display Cabinet:** A Small Glass fronted casing on the left column used to advertise shows. **c**

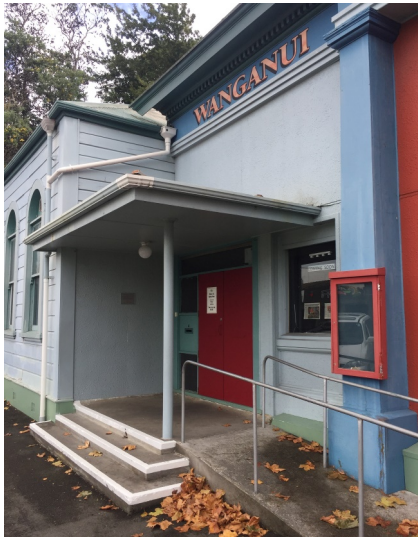
## Front Entrance:

**Entry, Columns and Entablature:** While the original columns and pilasters have been removed, the pediment and dentil decoration remains, and should be maintained and if necessary restored to ensure its longevity. Currently requiring fresh paint but otherwise in good condition.

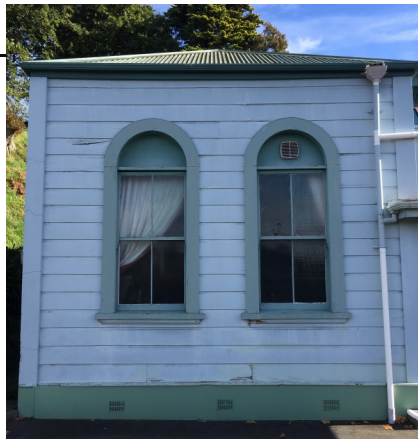
## Front Façade on South Western extension:

**Windows:** Timber Double Hung Sash Windows, Timber Sills, Jambs & facings with a single panes of frosted glass and painted out glass to arched top panels. Vent in toplight should be removed. Currently requiring fresh paint but otherwise in good working condition.

**Air Vent in window:** On the toplight pane of the right window an air vent detracts from the existing façade and should be removed and replaced by a better concealed ventilation alternative.

**Weather boards & Corner boards:** 255mm cover paint finished. Evidence of rot which will require further inspection and in instances to be replaced

**Gutter:** Periodically replaced and of little architectural merit

**Foundation wall and sub Floor Air Vents:** Masonry, in good condition. Paint finished. Metal vents still in reasonable condition.

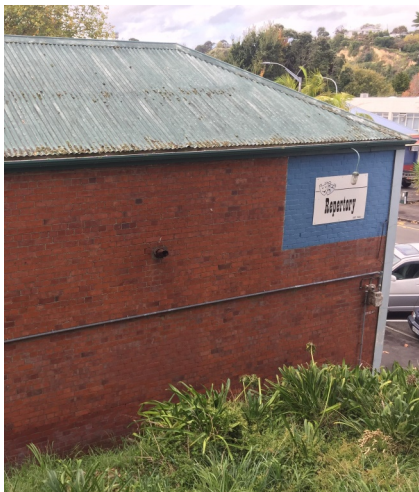
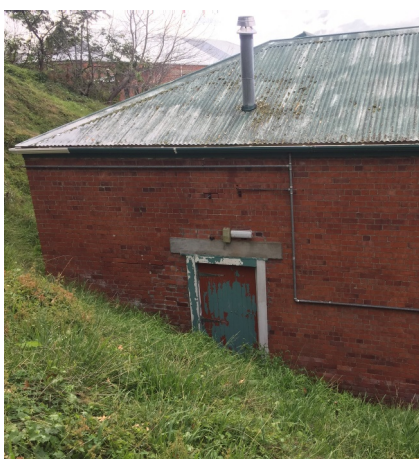
South West Facade

**Brick Wall:** Constructed as a part of the 1894 Library extension, the decision to construct the brick facade on the west façade of the building reflects the early 20th century regulations which sought to limit the spread of fire. While this façade is therefore architecturally more contemporary than the original building, it is in keeping with many other predominately wooden historic buildings with brick party walls around Whanganui. In good condition aesthetically, refer to structural engineers report for structural assessment of the party wall.

**Gutter:** Periodically replaced and of little architectural merit

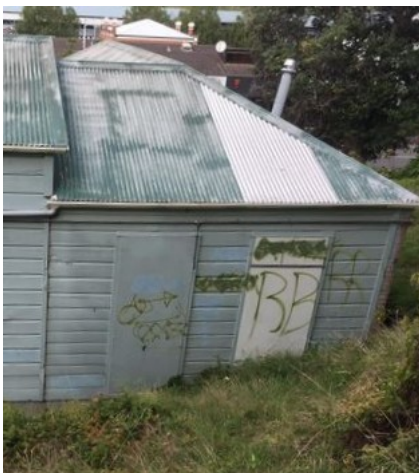
Rear (North) Façade of West Extension

**Weatherboards:** Constructed as a part of the 1894 Library extension, the weatherboards on the rear façade of the west extension were selected to match the adjacent original weatherboards. As non-original and grossly unseen elements the architectural merit of these weatherboards lies largely in the fact that they match the original weatherboards. Currently requiring fresh paint but otherwise in good condition.

**Gutter:** Periodically replaced and of little architectural merit

**Concrete retaining:** Constructed as a part of the 1894 Library extension the retaining wall on the back corner of the west extension is no longer very visible as a result of the erosion of the bank. As a consequence of this, the condition of the retaining is questionable and poses a risk to the conservation of the building.

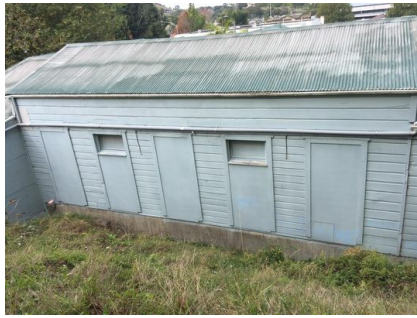
## Rear (North) Façade of Original building

**Weatherboards:** Currently requiring fresh paint but otherwise in reasonable condition.

**Gutter:** Periodically replaced and of little architectural merit

**Concrete retaining:** Original retaining the condition of which is questionable as a consequence of the eroding bank which it has come to retain. The choice of concrete retaining here reflects the original intention that this façade would not be frequently accessed or viewed by the public

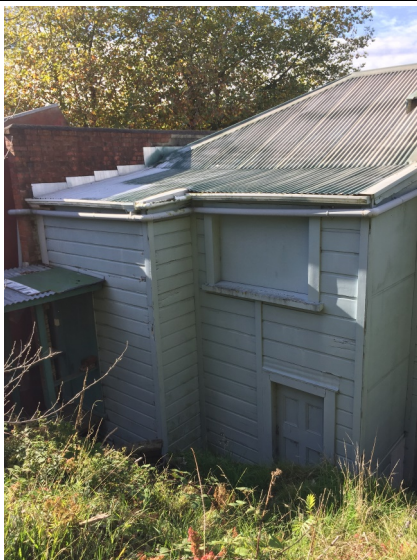
## Rear Façade of North Eastern Extension

**Weatherboards, High Level Covered opening, Ground Level sealed door:** Thought to have been added as an extension to the eastern wing of the theatre as a part of the 1957 alterations. The building elements which make up this section of the back façade are of no considerable architectural merit but can equally be acknowledged as in keeping with the original section of façade that they neighbour. Currently requiring fresh paint but otherwise in good condition.

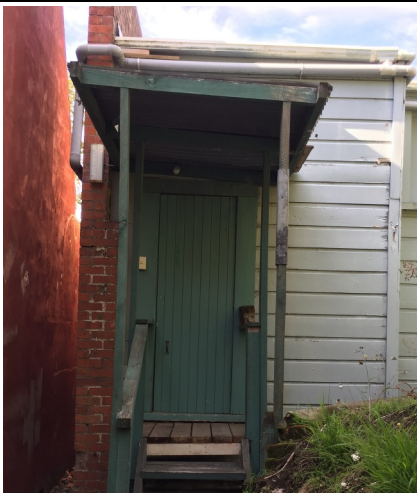
## Back Fire Exit off Stage

**Portico, Steps & Landing:** In Poor condition, the existing fire exit, which provides egress from backstage, is no longer fit for purpose and needs to be replaced. Refer to Fire Engineer's Report

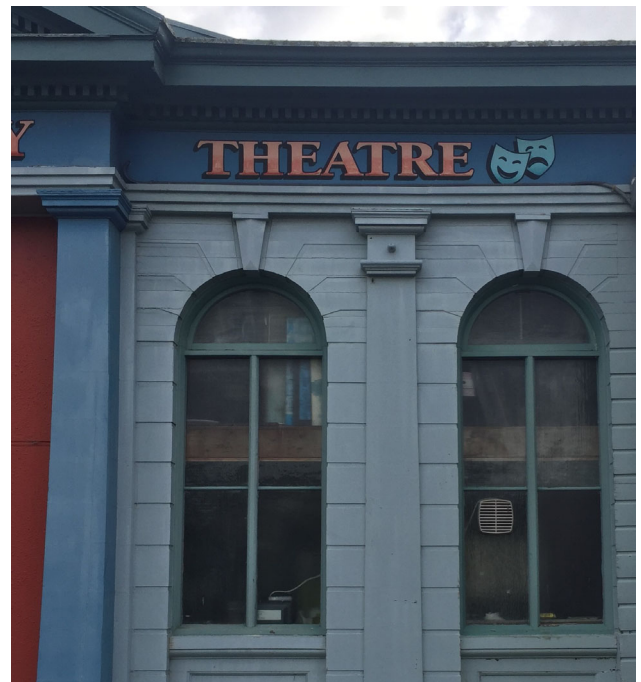
*Figure 18:* Front façade showing mezzanine floor built across window openings.
