# CONSERVATION REPORT

## The WHANGANUI REPERTORY THEATRE

ADDRESS: 4 Ridgway Street, Whanganui Old Town  
DATE PREPARED: 3 December 2021  
REVISED: /  
PREPARED FOR: The Committee, Whanganui Repertory Theatre  
Incorporated  
PREPARED BY: Drawingroom Architecture & Interiors in association with  
BPL Group & Fire Engineering Services Ltd.  
LEGAL DESCRIPTION: Pt Section 548, Town of Wanganui

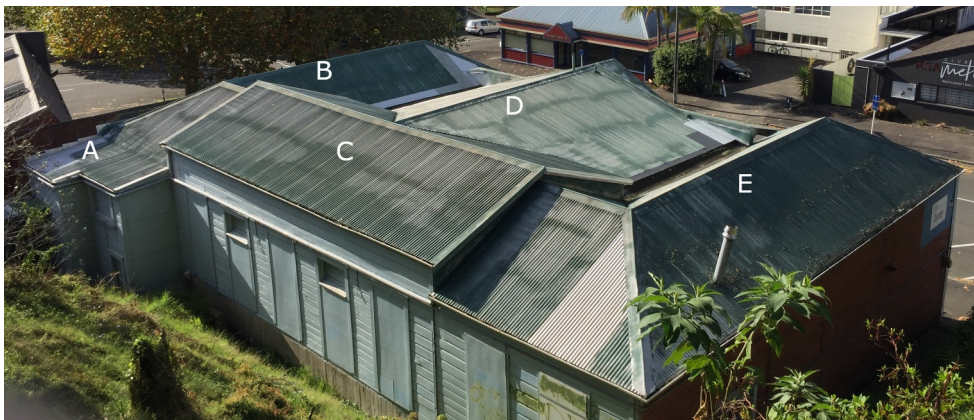
ROOF	Hipped and gabled corrugated iron clad roof forms.	C
A	Lean-to roof over Eastern Fire Exit extension: Corrugated iron added as part of recent extension, lined with building paper	D
B	Gable roof over North Eastern extension: Relatively recently replaced corrugated iron roofing, lined with building paper	C
C	Gable roof over Atrium and Stage: Recently recently replaced corrugated iron roofing, lined with building paper	C
D	Gable roof over Entry Foyer, Green room, Box Office, Dressing Rooms, Toilets: & Mezzanine Floor: Recently replaced corrugated iron roofing, lined with building paper	C
E	Gable roof over Western extension: Recently replaced corrugated iron roofing, lined with building paper	C

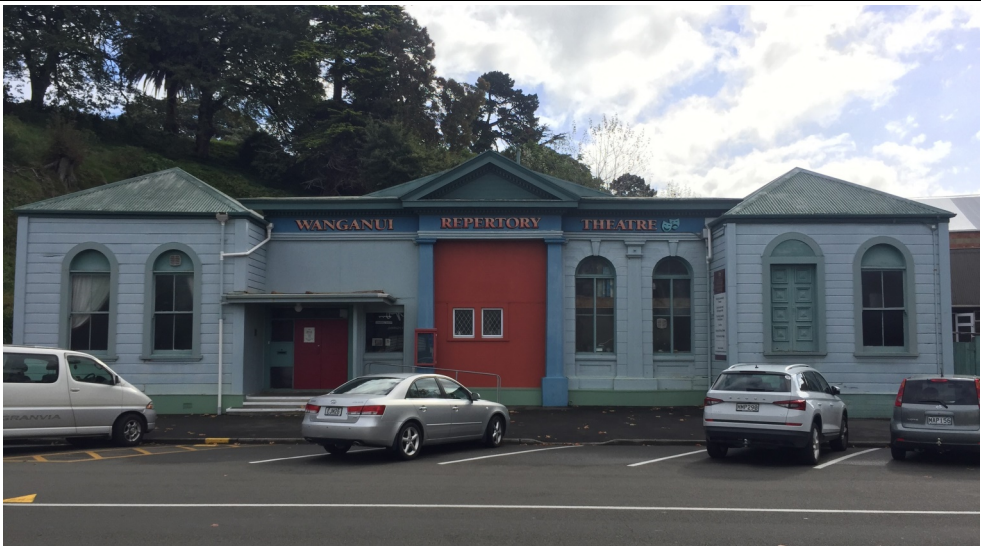
Front  
(South  
East)

**Window:** Timber Double Hung Sash Window, Timber Sill, Jambes & facing with single pane of frosted glass and paint finished arch top panel. Requiring fresh paint but otherwise in good condition. **b**

**Door:** replaced window in order to provide prop access point for offsite fabricated props for the theatre in the early 20<sup>th</sup> C. Requiring fresh paint but otherwise in good condition. **b**

**Weather boards & Corner boards:** 255mm cover paint finished weatherboards. Evidence of isolated rot which will require further inspection and in instances to be replaced **b**

**Gutter:** Periodically replaced and of little architectural merit **d**

**Foundation wall:** In good condition. Paint finished. **c**

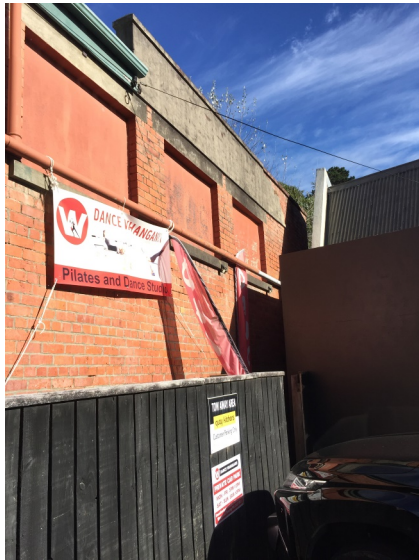
## Rear corner of North Eastern Façade

**Portico, Steps & Landing:** In Poor condition, the existing fire exit, which provides egress from backstage, is no longer fit for purpose and needs to be replaced. Refer to Fire Engineer's Report

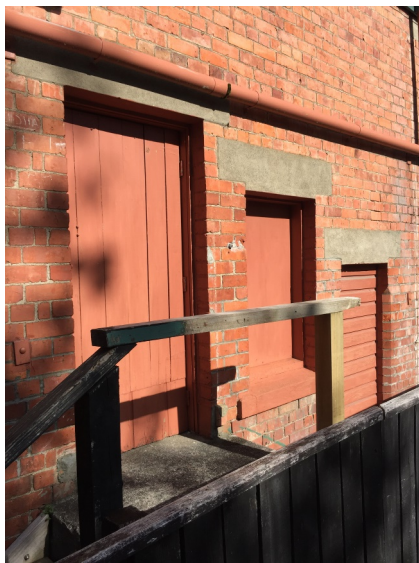
**Fire Door, Wooden Steps & Landing:** In poor condition, the existing fire exit, which provides egress from backstage and workshop, is non compliant and no longer fit for purpose and needs to be replaced/ removed. Refer to Fire Engineer's Report

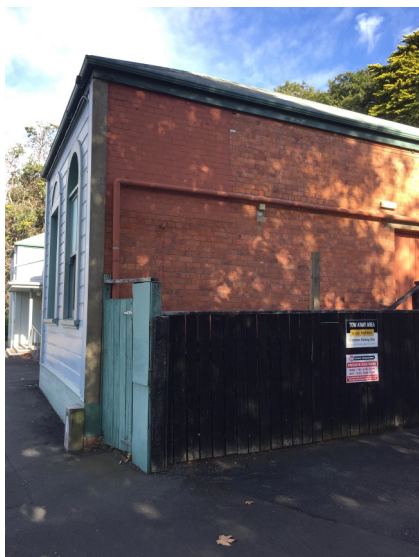
**Gutter & Down pipes:** Periodically replaced and of little architectural merit

**Fence:** Periodically replaced and of little architectural merit

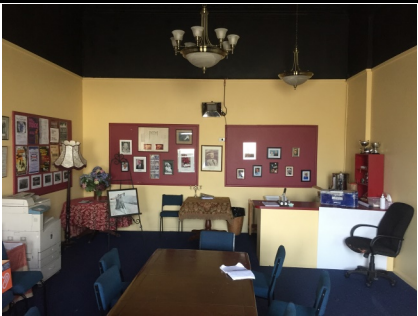
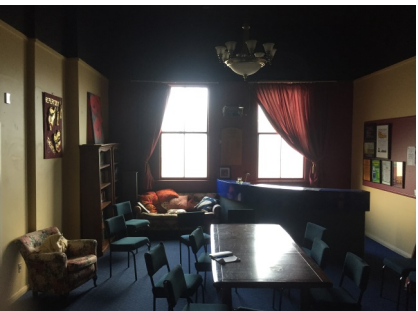
Supper Room		C
1

<p><b>Ceiling &amp; Cornice (Image 3):</b> Dating back to the 1894 construction of the west wing. Good condition requires minimal attention b</p> <p><b>Walls &amp; Floor Linings</b> d</p> <p><b>Window Trims (Image 4):</b> Dating back to the 1894 construction of the west wing. Good condition requires minimal attention b</p> <p><b>Bar</b> d</p>
2

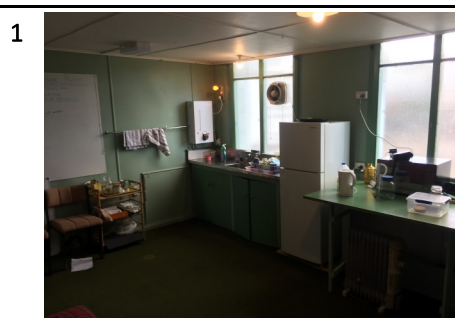
Green Room	C
------------	---

Ceiling , Walls & Floor Linings	d
Window Trims (Image 2): Outside of the recent paint the window trims are original and still in good condition	a
Lighting	d

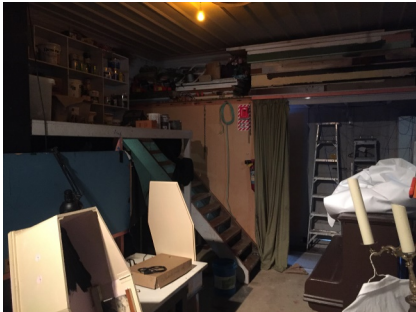
<p><b>Ceiling &amp; Cornice (Image 2):</b> Dating back to the 1904 construction of the East wing. Average condition due to the fitting of lighting and curtains through ceiling .</p> <p><b>Wall &amp; Floor Linings</b></p> <p><b>External Prop Door and Linings (Image 3):</b> Opening onto Ridgway street the French doors on the south eastern side of the workshop were retrofitted in the early 20<sup>th</sup> C in order to provide prop access for the Theatre. The linings date back to the 1904 of the East wing</p>	<p>c</p> <p>d</p> <p>b</p>
2	 	<p><b>Work Shop Storage Space</b></p> <p><b>Lighting</b></p>	<p>d</p> <p>d</p>
3

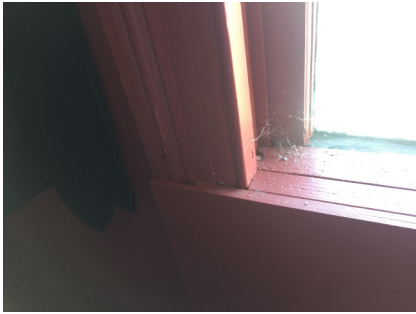
<p>Ceiling , Walls &amp; Floor Linings d</p> <p>Plumbing Fixtures d</p> <p><b>Window Trims (Image 2):</b> The workshop bathroom faces onto the Arch topped window of the main façade dating back to the 1904 construction of the East Wing. The ceiling of the bathroom currently divides the window. Good condition requires minimal attention b</p> <p>Lighting d</p>
2

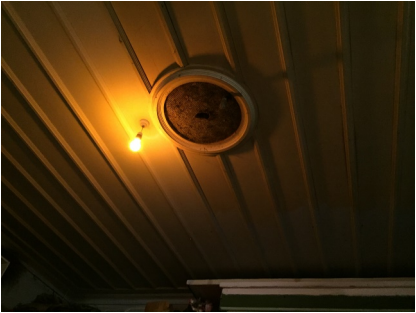
2

<p><b>Ceiling &amp; Cornice (Image 2):</b> Dating back to the 1904 construction of the East wing. Average condition due to the fitting of lighting and curtains through ceiling. b</p> <p>Wall &amp; Floor Linings d</p> <p>Fire Doors d</p> <p>Curtains &amp; Partition Walls d</p> <p><b>Stage:</b> Elevated 800mm above the East Wing floor the existing stage was constructed in the early 20<sup>th</sup> C when the Library was converted into a Theatre. The condition of the stage and sub floor and requires attention and is in some instances dilapidated and unfit for purpose. c</p> <p>Lighting d</p>

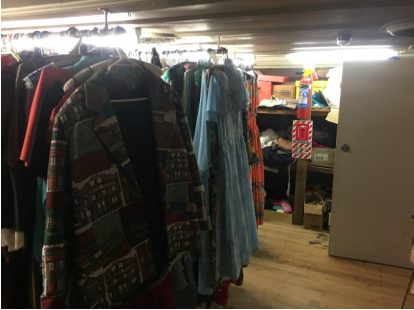
<p><b>Ceiling &amp; Cornice (Ceiling rose image 3):</b> The Original timber ceiling and cornices still form the ceiling in the mezzanine although in instances these have been covered with a cardboard lining. The ceiling construction is as described in 3.2.2 with a central timber framed round rose. The condition of the ceiling is very poor and would require extensive restoration in order to maintain</p> <p><b>Wall &amp; Floor Linings.</b> Appear to be Matai or similar native tongue &amp; groove planks over a timber structure. This floor was probably added in the 1930's.</p>
2

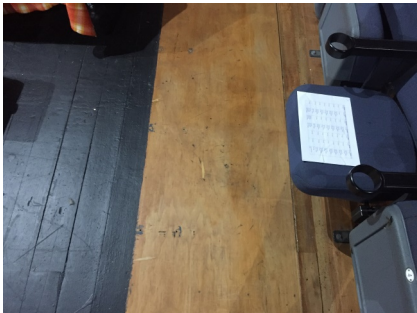
2

<p><b>Ceiling &amp; Cornice (Image 2):</b> Original Features. Average condition due to the fitting of lighting and curtains through ceiling which are essential features to the function of the theatre</p> <p><b>Floor (Image 3):</b> Reconstructed in the early 20<sup>th</sup> C when the Library was converted into a theatre. Still in reasonable condition requiring only minor restoration</p> <p><b>Wall Linings</b></p> <p><b>Proscenium Arch:</b> Widened in the 1950's</p>

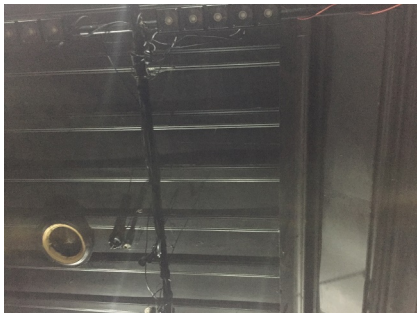
<b>Covered openings (Image 4):</b> Along the external wall of the auditorium original windows were positioned to light the interior of the original library. They have subsequently been covered over in order to keep the auditorium sufficiently dark for theatre performances. The condition of these is subject to further investigation and would require the removal of the wall linings currently covering them. It is worth noting that these opening are no longer fit for the purpose of the theatre due to their low light, sound and thermal insulation value.	b
3

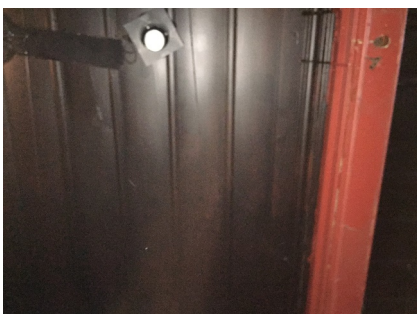
<b>Ceiling &amp; Cornice: (image 2)</b> Dating back to the 1894 construction of the West wing. Good condition requires minimal attention  <b>Wall Linings</b>  <b>Floor Linings (image 3)</b> Reconstructed in the early 20 <sup>th</sup> C when the Library was converted into a theatre. Still in reasonable condition requiring only minor restoration  <b>Fire Door</b>	b  d  b  d
2
